North Hyde Review Final Report

30 June 2025

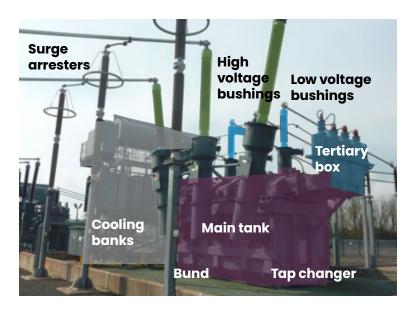
Figure 5: Illustrative location of bushings within a supergrid transformer

- 6.8 After disassembly of the bushings, Doble found evidence of moisture ingress on the C-phase high voltage bushing that suffered the catastrophic failure. Such evidence of moisture ingress would not have been visible externally and therefore only became apparent after disassembly and forensic analysis post-incident by Doble.

- 6.9 The forensic analysis also found evidence of arcing erosions within the C-phase high voltage bushing. Arcing erosion is the damage caused by electrical arcs, which normally occurs due to electrical faults or contamination, including by moisture ingress. This damage can lead to the gradual degradation of parts of the bushings, and can result in reduced insulation resistance, potential short circuiting and ultimately, bushing failure. Phases A and B of the high voltage bushings did not show any evidence of arcing erosion, supporting the case that the fault was on the C-phase only and had arisen as a result of moisture ingress.

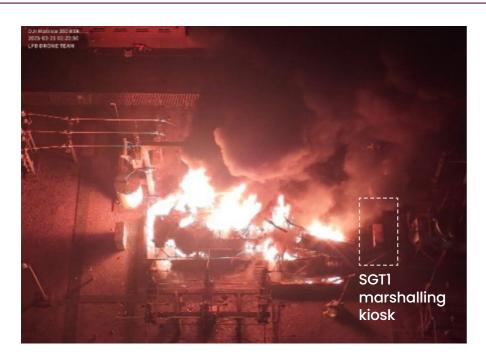
Figure 6: Aerial photo of SGT3 taken by London Fire Brigade drone, Friday 21 March 2025 02:22:50

- 7.2 While the fire occurred on SGT3, fire, heat and smoke impacted the wider North Hyde site. In particular, SGT1's marshalling kiosk was affected, and its wiring sustained significant damage. The marshalling kiosk for SGT1, as shown in Figures 6 and 7, was located to the west of SGT3, in between SGT3's cooling system and SGT1.

- 7.3 The wind direction at the time of the incident was instrumental in causing the damage to SGTI's marshalling kiosk due to the fire and heat directed towards it. In contrast, the marshalling kiosk for SGT3, which was upwind of the fire, remained largely undamaged. The damage to the marshalling kiosk for SGT1 and the wiring inside it may have triggered SGTI's protection systems to operate, automatically switching SGT1 and the circuit connecting it to the wider transmission system out of service.

- 7.4 National Grid Electricity Transmission's internal review has indicated from preliminary findings that the catastrophic failure of SGT3's C-phase high voltage bushing ejected pieces of porcelain insulator at high velocity, causing collateral damage to the A-phase high voltage bushing of SGT1. National Grid Electricity Transmission states that it is highly likely, although not confirmed, that a flashover on the A-phase high voltage bushing on SGT1 caused by a combination of heat, oil fire smoke and physical damage might also have triggered SGT1's protection system to operate.
