North Hyde Review Final Report

30 June 2025

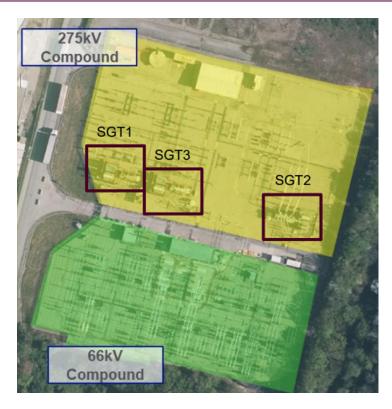
Figure 1: Image of North Hyde site

- 5.2 The North Hyde site is located east of Hayes in West London. There are four substations at the site: the 275kV (controlled by National Grid Electricity Transmission) and the 66kV, 22kV and 11kV (all operationally controlled by SSEN Distribution).
- 5.3 There are three supergrid transformers at North Hyde, located in the 275kV substation compound; SGT1, SGT2 and SGT3. These transformers are designed to reduce the voltage from 275kV to 66kV and are owned by National Grid Electricity Transmission.
- 5.4 SGT1 and SGT3 were commissioned in 1968 and are adjacent to one another. SGT2 was commissioned in 2010 and sits over 30 metres away from the other two transformers (see Figure 1).
